Lessons from ten years storm water infiltration in the Dutch Delta

Beenen A.S.* , Boogaard F.C.**

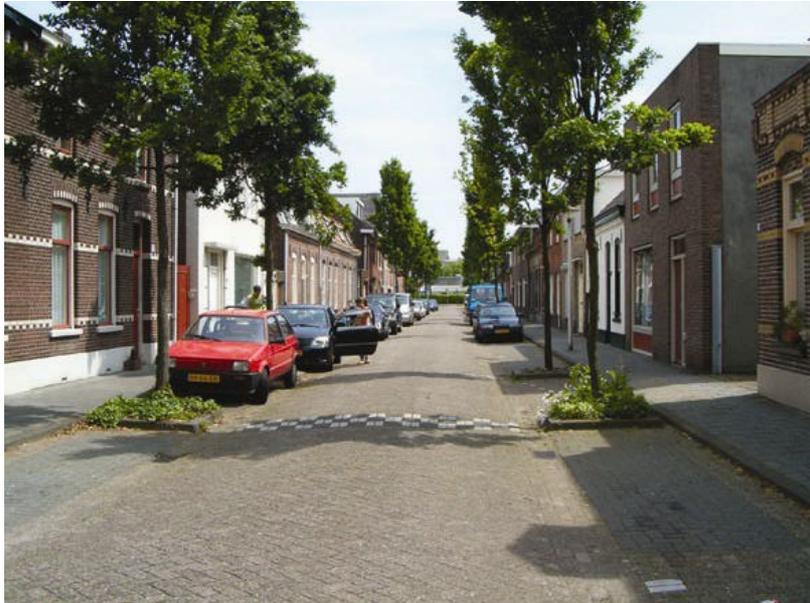
Run-off in the Runstraat in Eindhoven is disconnected to soakaways

In 1997, a testing project has been initiated to analyse the functioning of sustainable urban drainage systems (SUDS) and to determine the hydraulic life expectations of two soakaway constructions made of ten plastic geocellular units wrapped in geotextile. These systems are monitored over a long period of time in order to obtain representative data.

To obtain the necessary data to gain insights in the hydraulic functioning of the infiltration systems, water level data loggers were used. The loggers measured every 5 minutes the water level in the infiltration unit and the ground water around the infiltration system. The precipitation was measured. In order to analyze the relation between precipitation and the water level in the infiltration system. Each month, the data was put in a database to analyze and visualize the hydraulic performance of this system in time. In 1996, the first measurements were conducted as reference for the follow-up research. In 200-2006, the infiltration systems were analysed again, comparing the outcomes with the initial data from 1996.

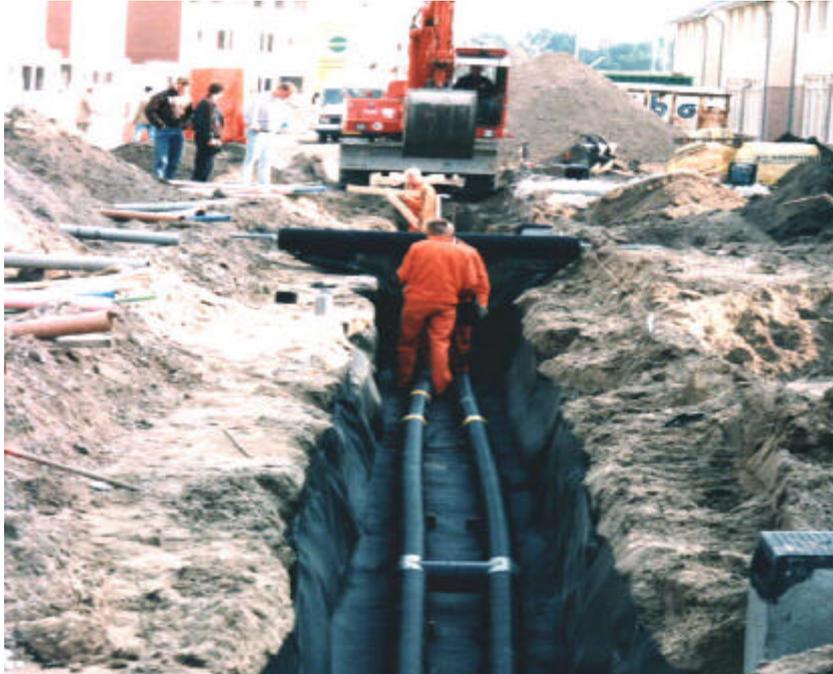
Construction of infiltration trench at Schellerhoek, Zwolle, Netherlands

The infiltration trenches were measured in two phases. The first phase took place in 1994-1997 when several times the water level in the infiltration unit was measured. The second phase was conducted in 2005-2006. The measured variables in this second phase were the water level in the infiltration system, the groundwater levels and the precipitation.

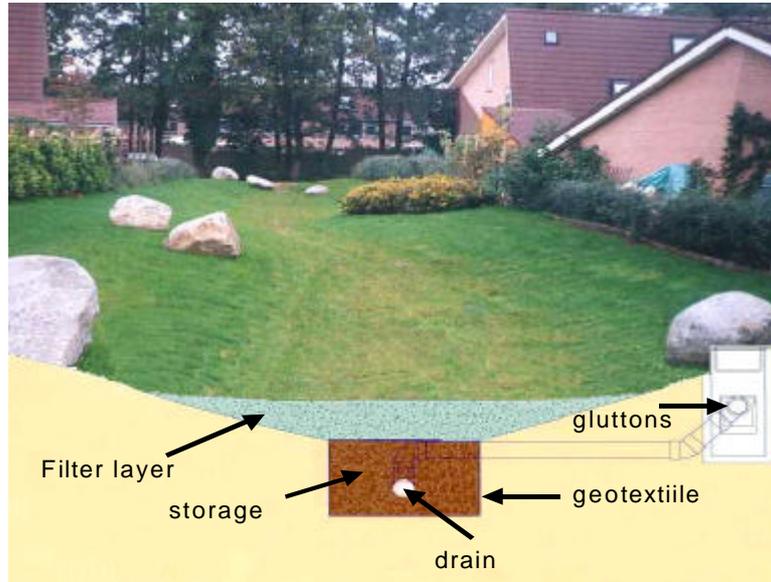
Swales in Ruwenbos

All run-off in *Ruwenbos* is guided through gutters along the streets and in this way is kept visible on the surface. The gutters guide the rain water to the swales. In each swale the water is stored to a level of approximately 0.25 metres, a level designed to be exceeded only once every two years. Above this level gullies, also called 'gluttons', discharge the surplus to a subsoil infiltration body made up of expanded clay grains wrapped in a geo-textile. Once every twenty-five years the water level in

the swale reaches a depth of 0.35 metres. Above this level the water is discharged into the next swale and, in the end, into the surface water.
